Newsletter – September 2018

Once again we are facing one of the key elements for operation of a ball mill: the trunnion.

SATAREM team in Latin America in coordination with technical personnel from one of the Cementos Argos plants in Colombia, fabricated a trunnion for a 1,500HP ball mill, according to **ASTM 1025** standard.

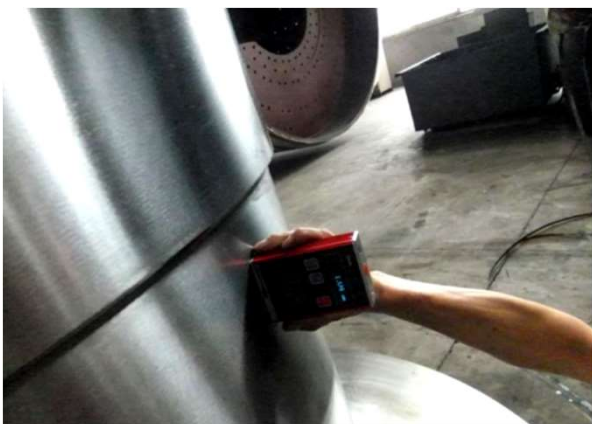
Due to the complexity of operation ultrasound examination is carried out, which allows SATAREM to give reliability and safety of equipment, likewise a dimensional verification is done according to plan and manufacturing measures.
